Re: Handover inspection property address

A visual inspection of the above property was carried out on 21st July, 2015.

The unit is one bedroom unit. The unit was un furnished at the time of the inspection.

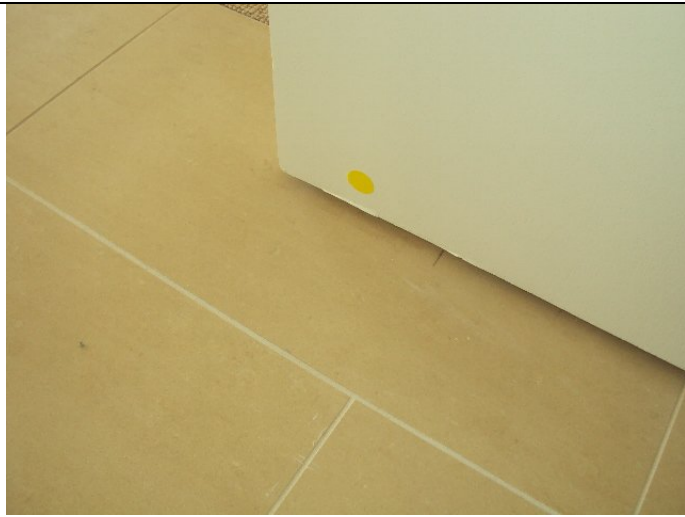
Damage to bottom of sliding door

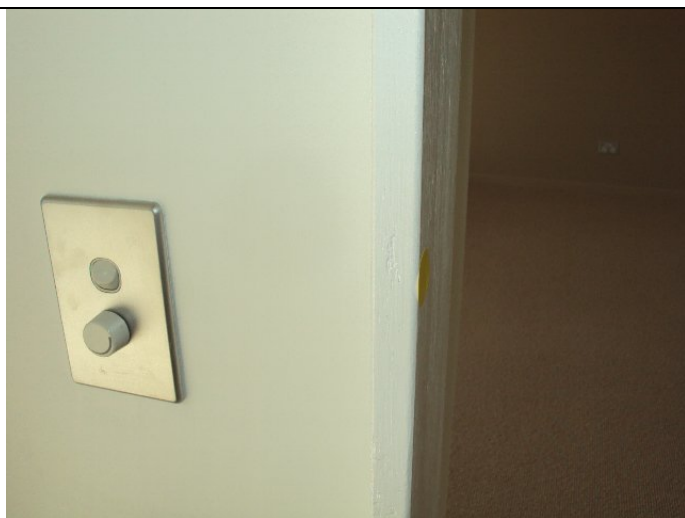
Poor finish to reveal to bedroom door

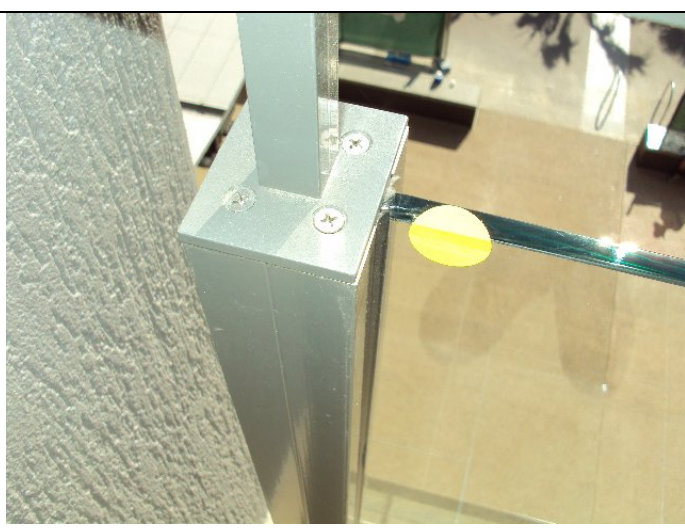
Chipped glass panel

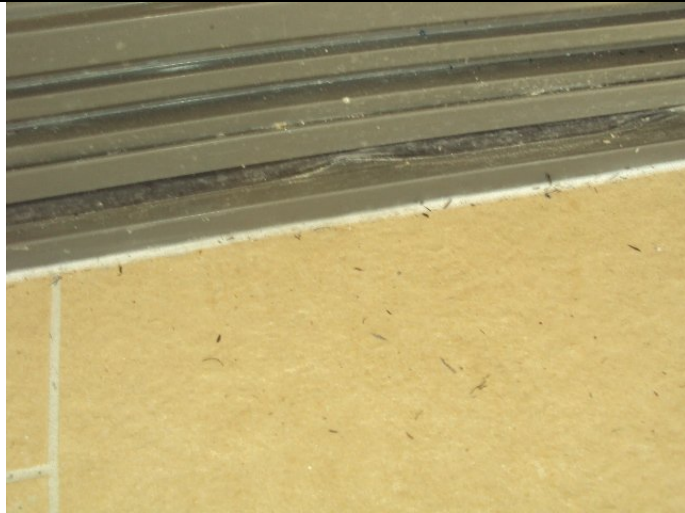
Rubber trim to base of doors

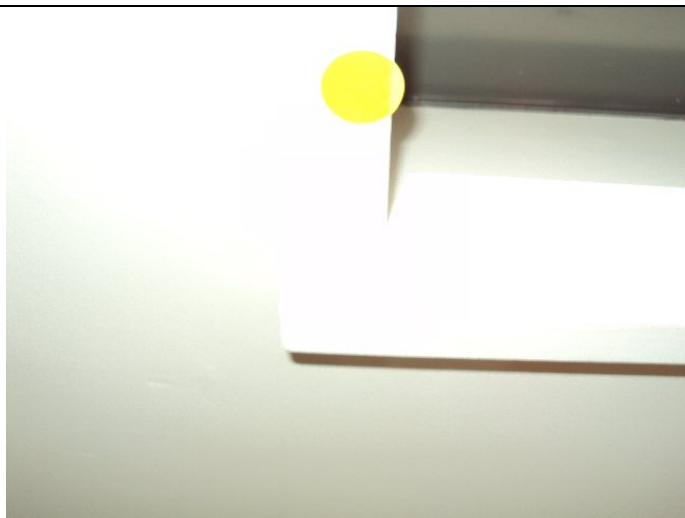
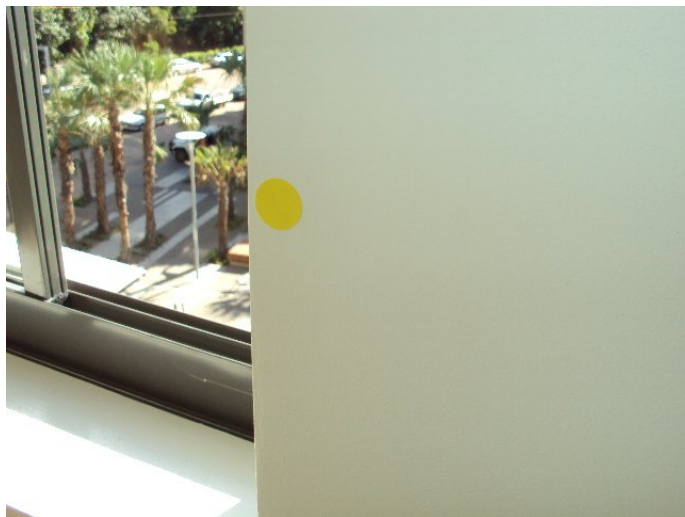
Poor preparation to reveals around bedroom window

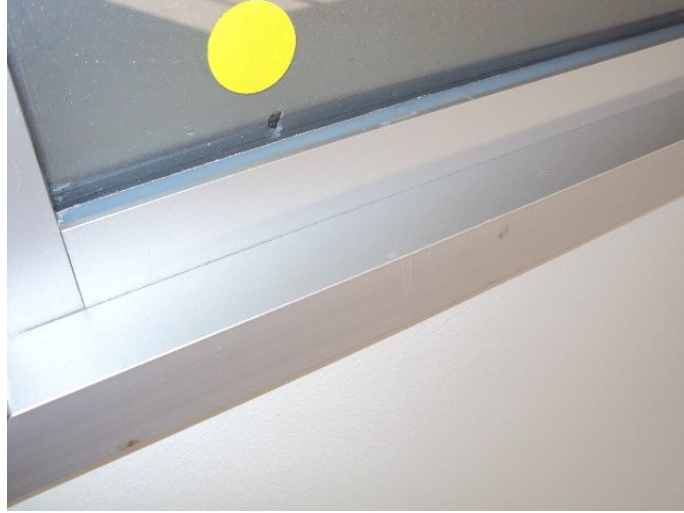
Damage to film on bathroom window

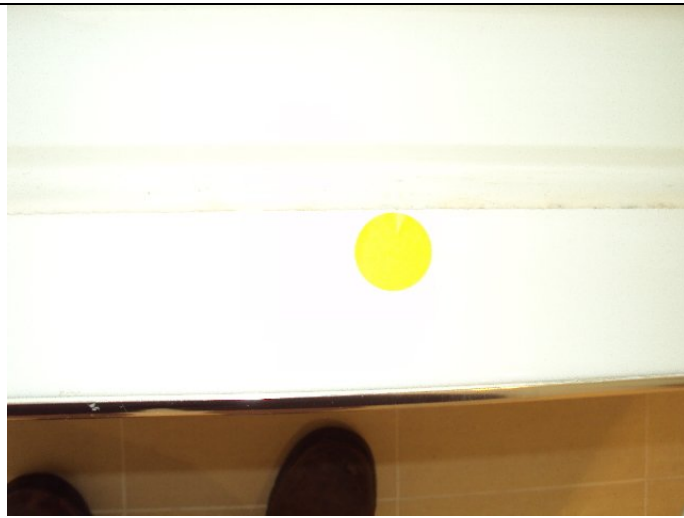
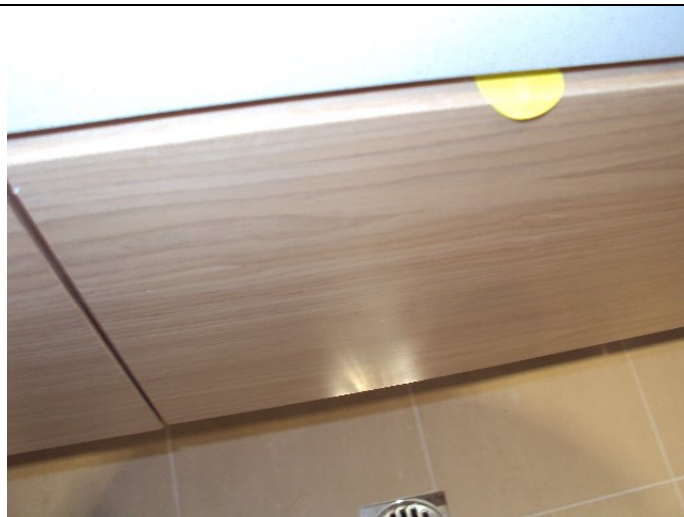
Discoloured sealant around bath

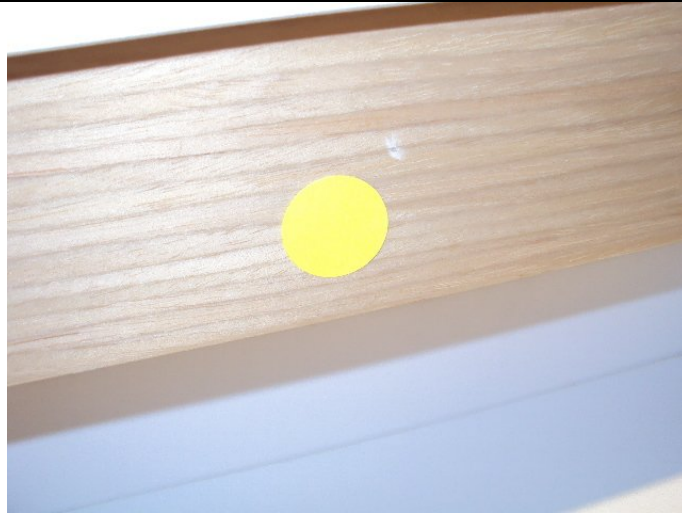
Marks to laminate from draw front fixing screw

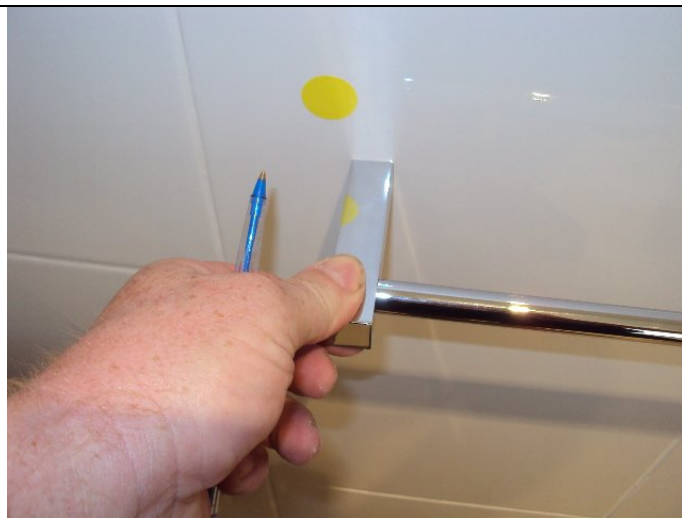
Loose towel rack

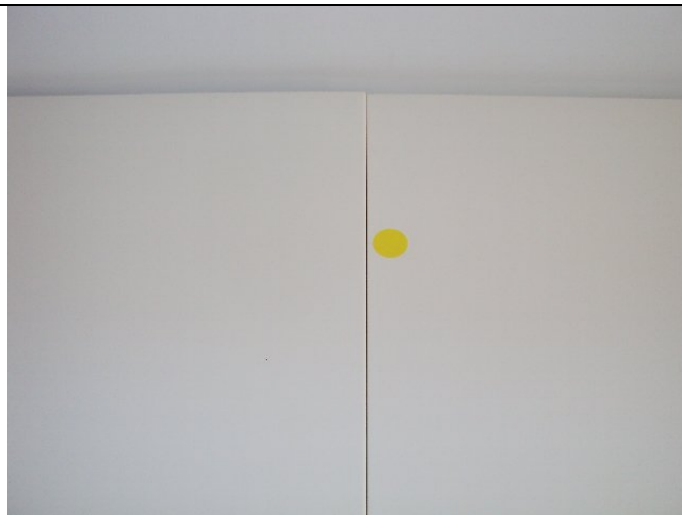
Binding robe doors

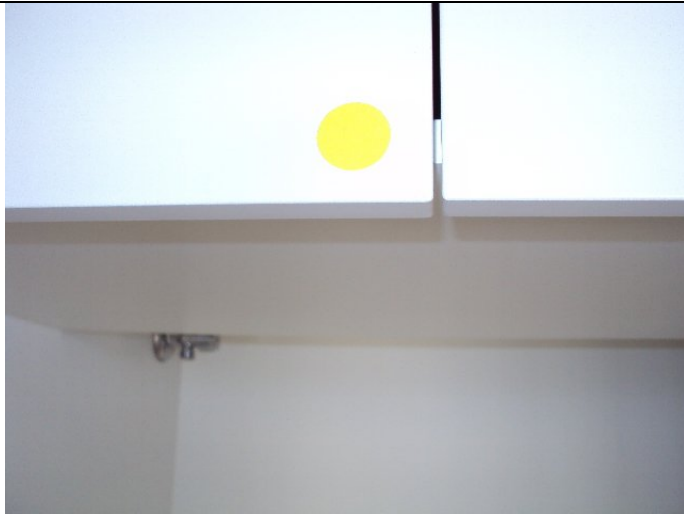
<p>Marks on doors above fried recess</p>

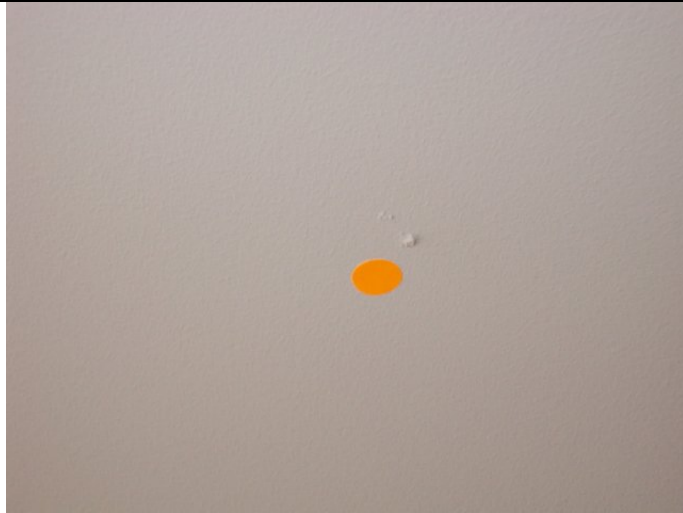
Lumps in paint finish

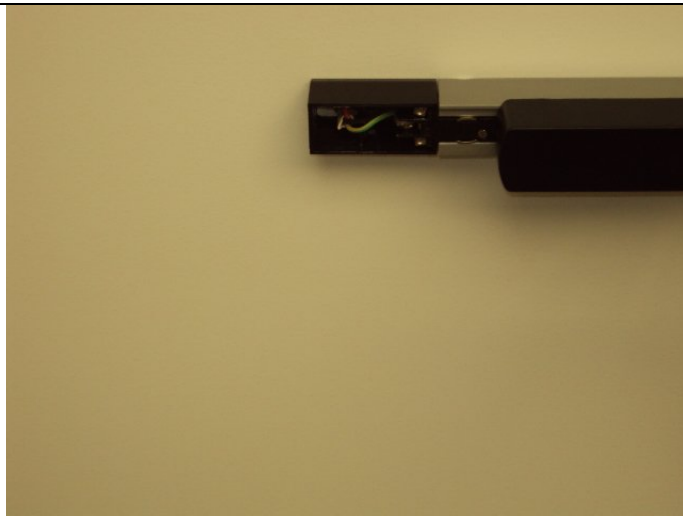
Missing cap from light fitting

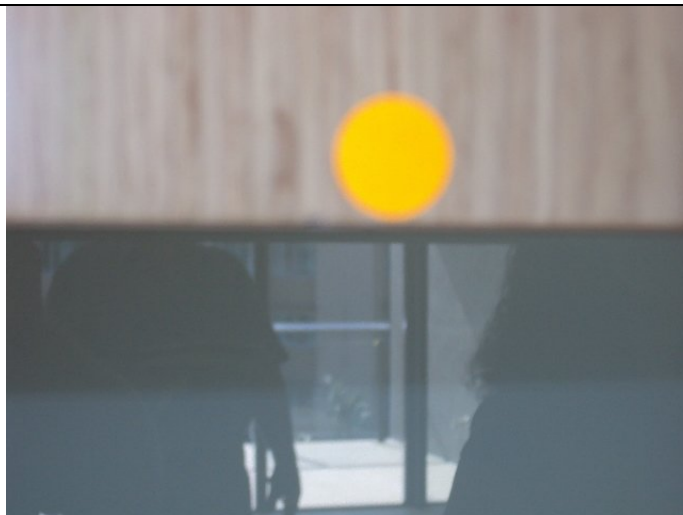
Marks on panels/doors on overhead cupboards

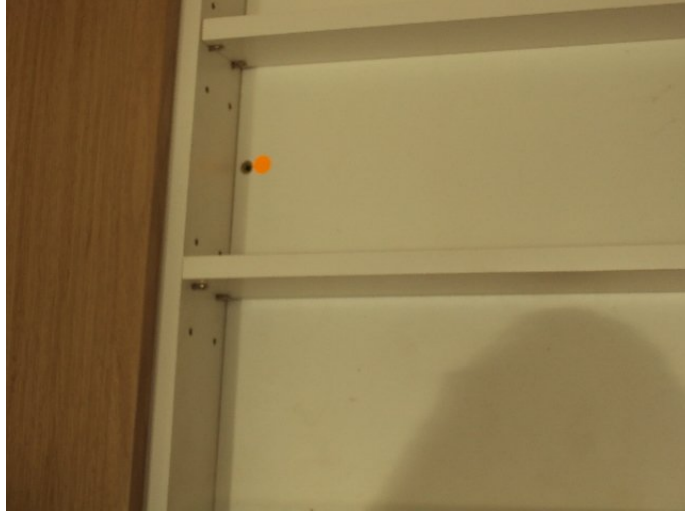
No screw caps
on fixings
above range

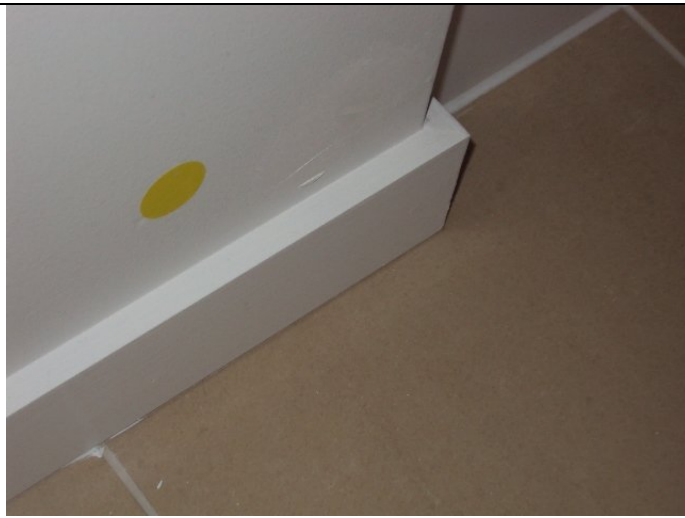
Poor
preparation
prior to
painting

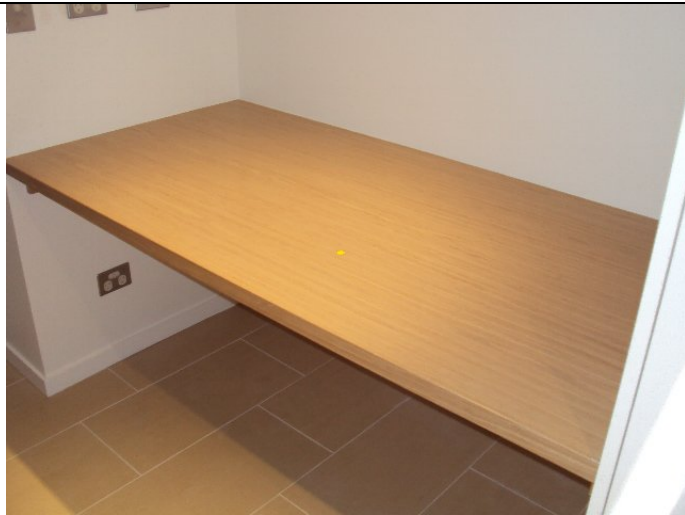
Damaged
bench top to
media centre
