**Re: Building Status Report for Lot 3256 6 Jones Street, Palmerston**  
**Purchaser: Name**

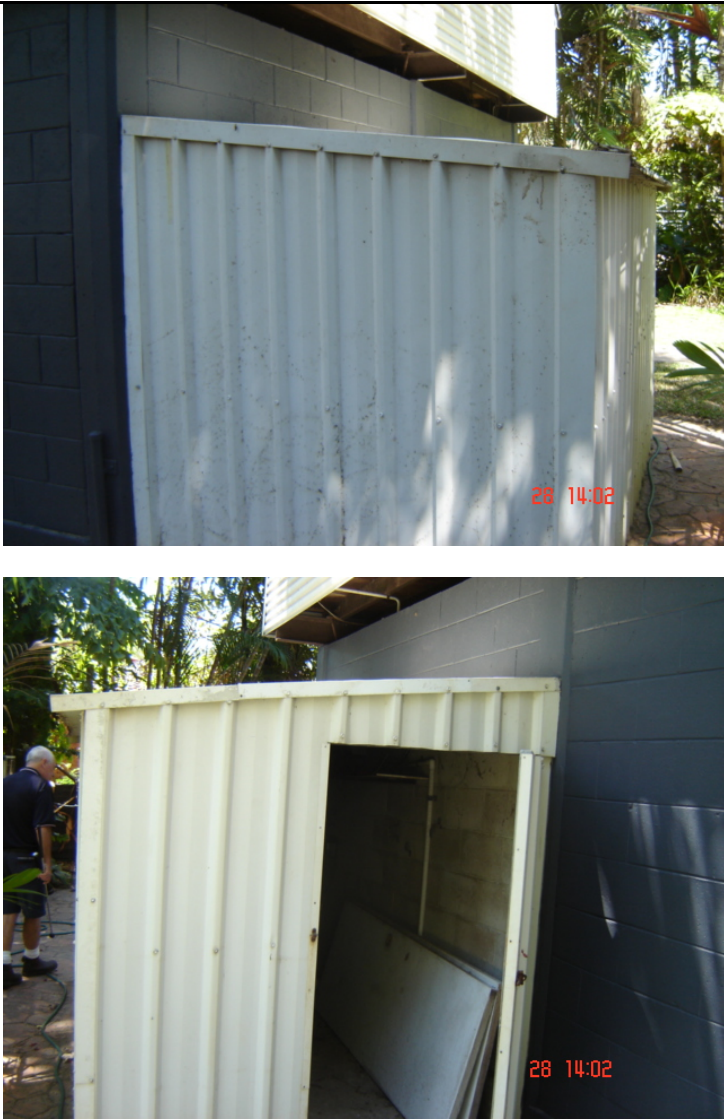
Structure	Status	Comments
House	Approved	<p>The Permit to Occupy was issued on 22/8/2001 approved under permit number 123/4567/1.</p> <p>While the layout fittings and fixtures are broadly consistent with the approved drawings the following inconsistencies were identified during the inspection:</p> <p>The lattice screens below the stairs and attached to the columns are not shown on the approved drawings.</p>

Garden Shed	Approved	The Permit to Occupy was issued on 18/5/2001 approved under permit number 123/4567/2. Copy attached for your information.
Tool shed	Approved	The Certificate of Occupancy was issued on 6/4/1994 under building permit number 1234567/3. Copy attached for information.
Verandah	Approved	The Permit to Occupy was issued on 20/11/1998 under building permit number 123/4567/4. Copy attached for information.
Storage shed	Unapproved	The storage shed attached to the rear of the property is not shown on the approved drawings or Building Approval.

Descriptor	Photos
<p>Unapproved storage shed attached to rear of the property</p>

<p>Unapproved lattice screens</p>
